REPORT ON THE LARGE-SCALE FIRE PROPAGATION PROPERTIES OF 80 mm THICK EXPANDED POLYSTYRENE (FR GRADE) UNDER- ROOF AND SIDE CLADDING INSULATION MATERIALS USING THE SANS 10177-11 TEST METHOD

3. PURPOSE OF THE INVESTIGATION

The purpose of the investigation was to evaluate the large-scale fire propagation properties of 80 mm thick expanded polystyrene (EPS) boards as an insulated system for thermal insulated building envelopes. The insulating system was tested for both under-roof and side cladding applications. The fire propagation properties of the thermal insulation system were also determined when installed in conjunction with a fixed sprinkler extinguishment system using slow response sprinkler heads.

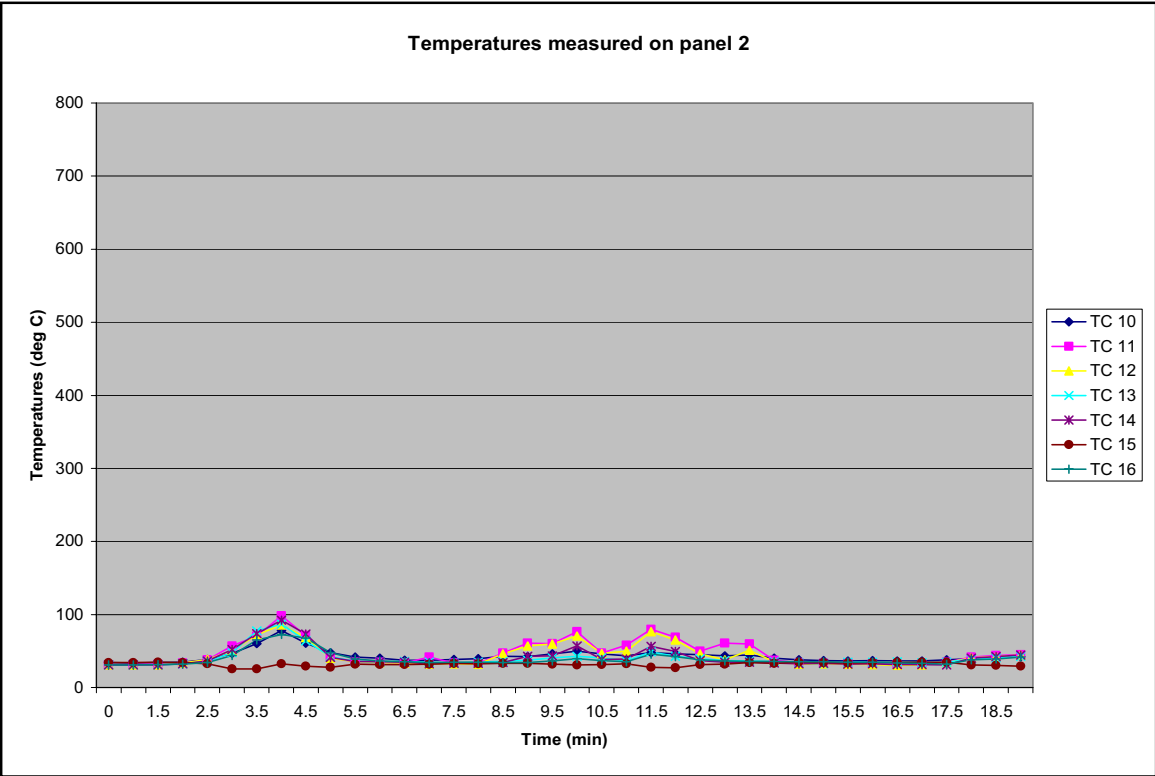
ANNEXURE A1:

Temperatures recorded during Test 1

The temperatures measured during the test are included in Annexure A1 with the photographic record contained in Annexure B1. The maximum heat output of

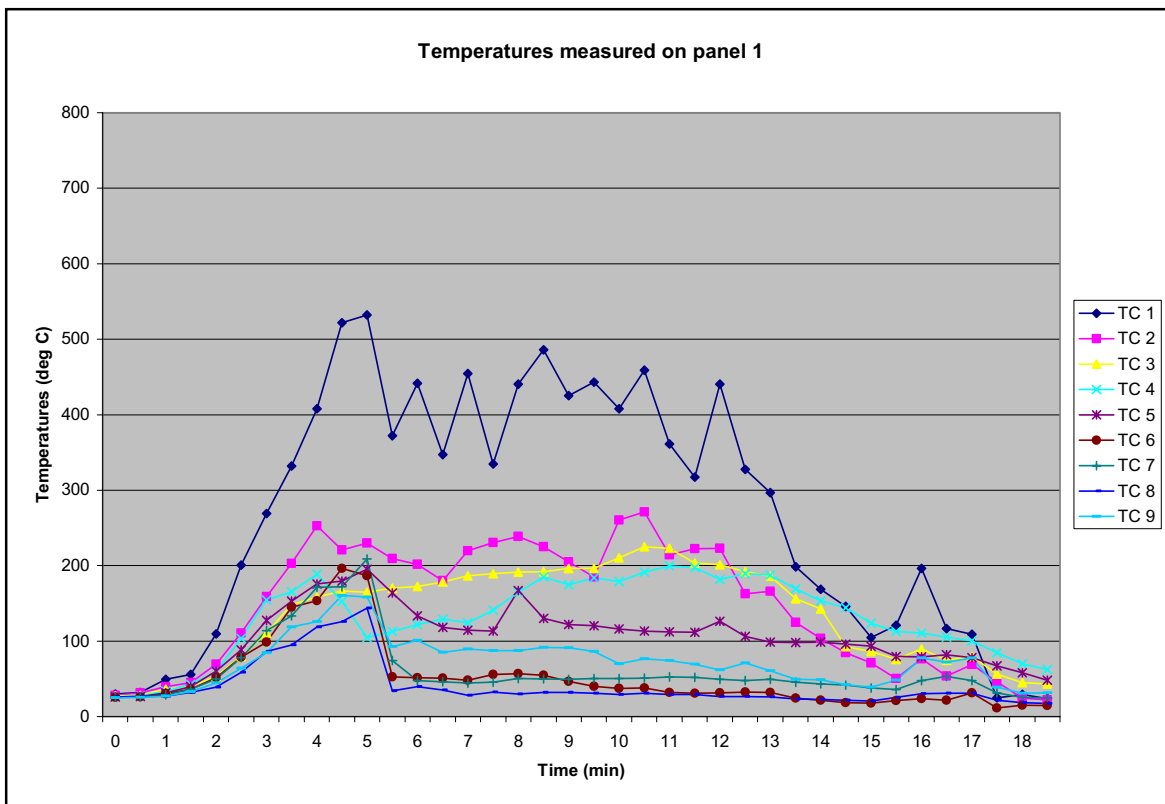
ANNEXURE A2:

Temperatures recorded during Test 2

decrease in the heat output was noted during this evaluation in comparison with the heat output noted during Test 1. This can be ascribed to the water released by the activated sprinklers influencing the rate of combustion of the starter crib. The temperature plot clearly indicates this decrease in heat output.

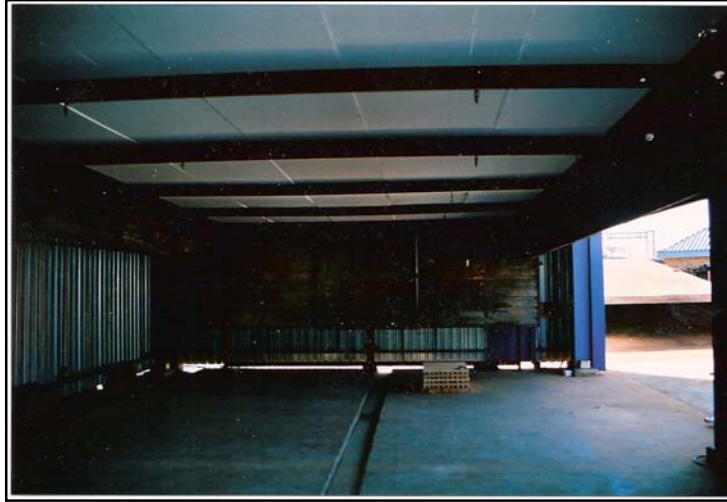
Figure B1-1: Installation prior to ignition of fire source

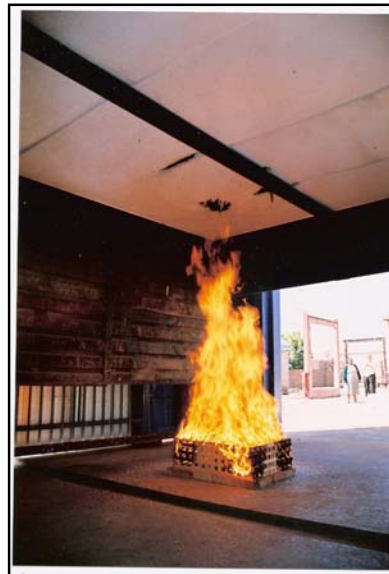
Figure B1-2: Material deforming and opening up in area above heat source (t = 4 min)

Time (min:sec)	Observation
0:00	Ignition of SA Pine ignition source.
3:52	Deformation of insulation panel above and around ignition source noted.
4:17	Deformation of material up to first purlin (2m) – no flaming.

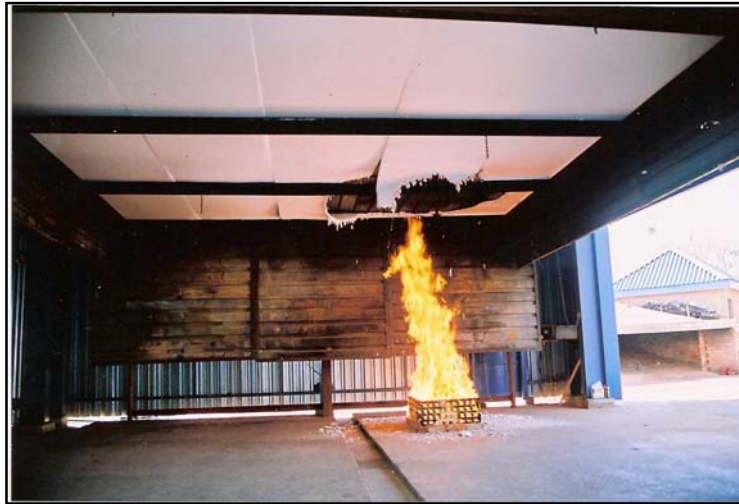
Figure B1-3: Larger area above fire source damaged but no ignition (t = 8 min)

The evaluation also showed that no ignition of the insulation took place during the test and that the heat damage was limited to first four metres of the installation. Although all the material in the installation was pre-heated by the fire source, only shrinkage of the joints was visible on the second 6 m x 6 m panel of the test installation with the last 6 m x 6 m panel remaining undamaged.

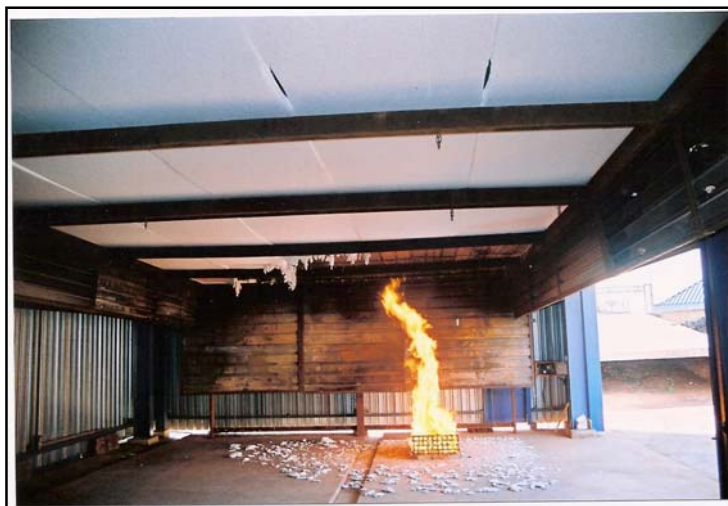
Figure B1-4: Fire source decaying – no further spread of damage to installation (t = 15 min)

13:24	Most of the material in the first section of the front panel have either dropped out or have distorted.
14:40	Material melted away on the surface of the second section of the front panel while also pulling away at the joints. No flaming noted.

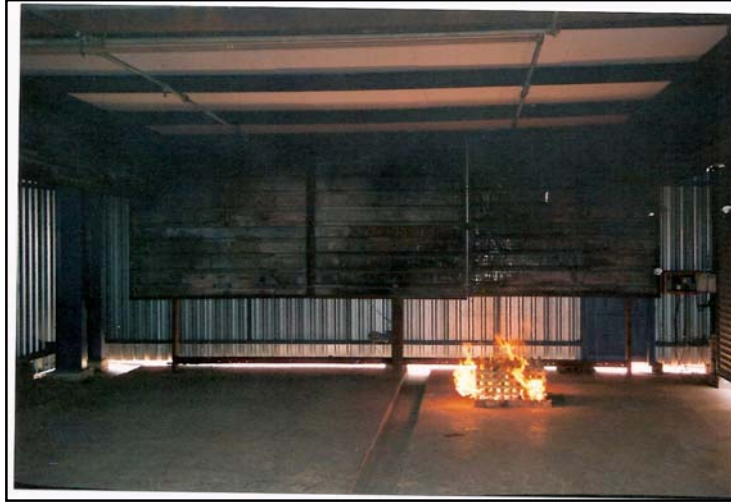
Figure B2-1: Test installation shortly after ignition of ignition source

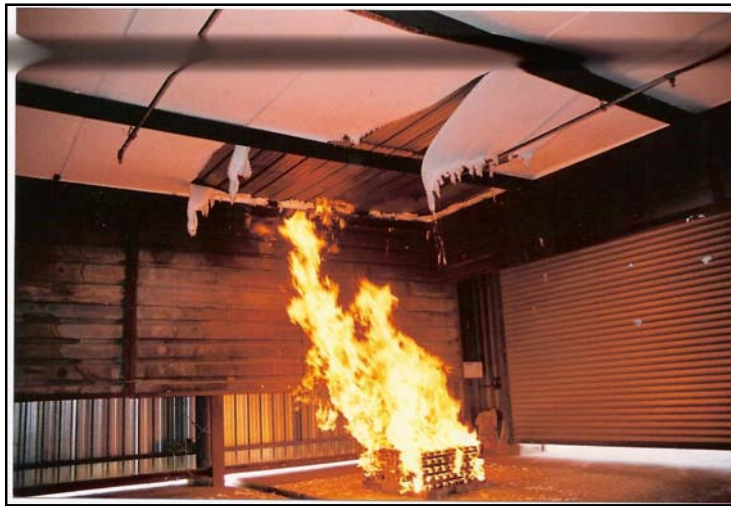
Figure B2-2: Installation damaged in area above fire source (t = 5 min)

Time (min:sec)	Observation
0:00	Ignition of SA Pine ignition source.
3:08	Deformation and melting of the material noted above the ignition source.
4:10	Material dropping down onto the floor of the facility.
7:26	The first sprinkler activated.
9:37	The second sprinkler activated.
13:05	The ignition source starting to collapse
15:00	The sprinklers were de-activated while the ignition source continued to burn.

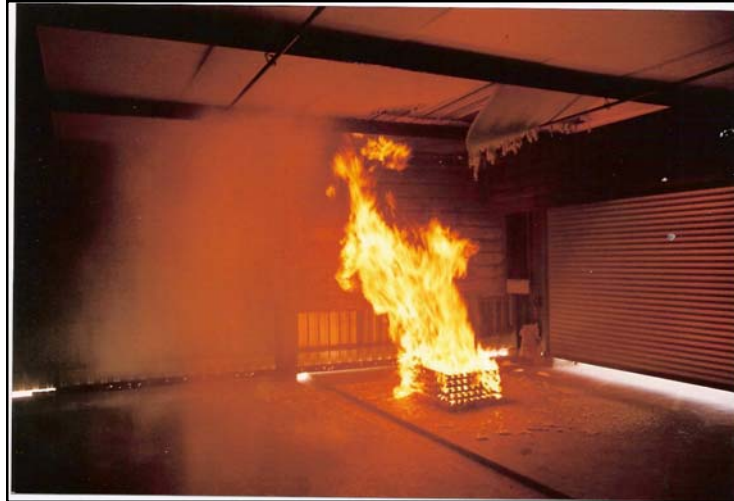
Figure B2-3: First sprinkler activated and operating unhindered (t = 7 min 30 s)

During the evaluation where a sprinkler system was installed, the damage to the material was notably less than during the evaluation without sprinklers. As before, no ignition of the material occurred. It can be stated, therefore, that the sprinkler activation decreased the heat damage to the insulation material. It was also shown that the insulation material did not affect the efficiency of the sprinkler installation.

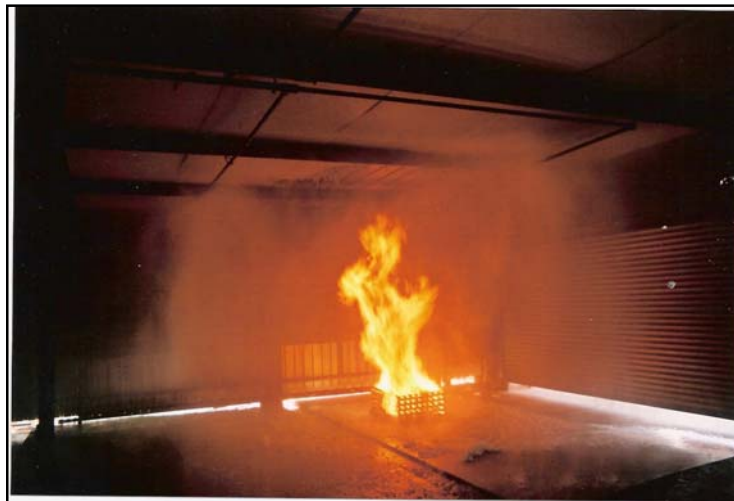
Figure B2-4: Second sprinkler activated, no further damage to test installation (t = 9 min 30 s)

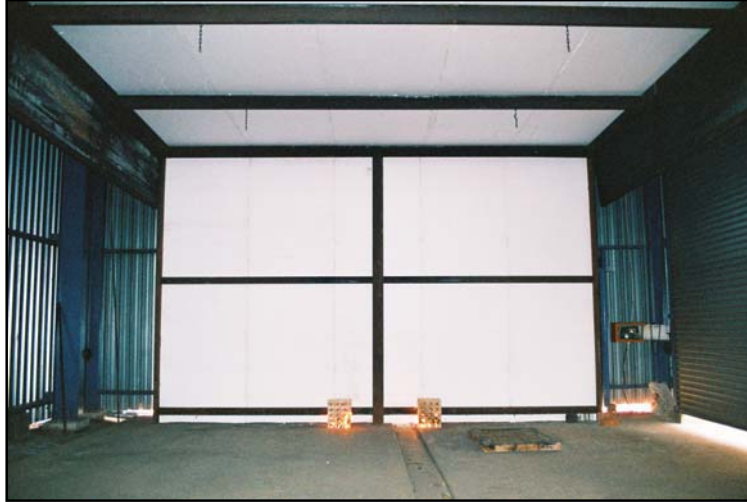
Figure B3-1: Test installation shortly after ignition of fire sources

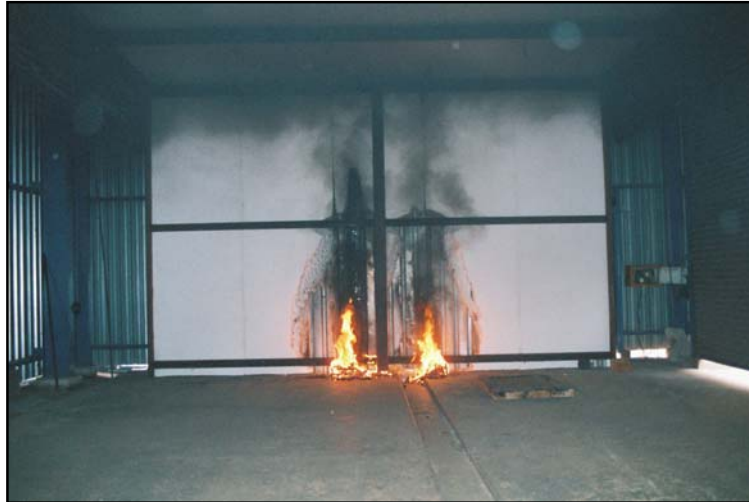
Figure B3-3: Starter packs collapsed against installation with some fallen material burning between bottom purlin and IBR sheeting (t = 19 min)

16:00	Left-hand ignition source collapse against the insulation.
16:43	Right-hand ignition source collapse against the insulation.
18:36	Flaming of the material noted between the bottom purlin and the IBR sheeting.

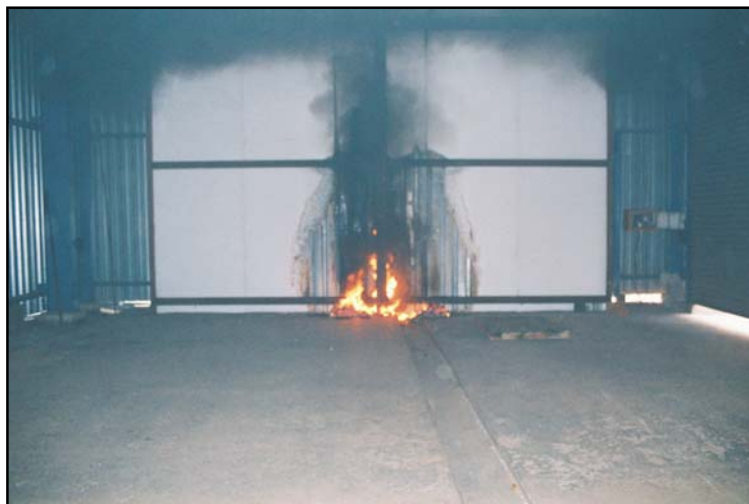
Figure B3-4: Limited flaming along vertical support element (t = 22 min), which seized at t = 24 min)

22:00	Slight vertical flame spread between the collapsed ignition sources and the vertical support element noted. Flaming was limited to approximately 1m above the ignition source

24:00	Ignition sources nearly burnt out with flaming of the insulation material having stopped.
